Inspection Report
Minerals Regulatory Program
Report Date: July 18, 2005

Mine Name: Small Fry
Operator Name: Molycorp

Permit number: M/037/022
Inspection Date: June 9, 2005
Time: 3:00-4:00 PM

ATTACHMENT
Photographs
M/037/022, Small Fry Mine, Molycorp
Inspection Dated: June 9, 2005; Report Dated: July 18, 2005

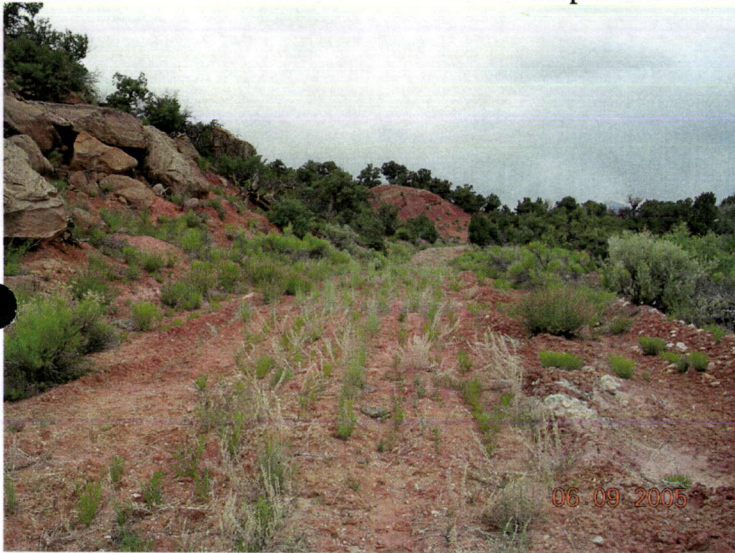
The vegetation has progressed a lot since the last time I visited this site about a year ago. The grasses are much better established, and there are numerous rabbitbrush and fourwing saltbush seedlings. Many of the grass plants had a fungus, probably a smut, in the seeds. Photo 1 shows the access road, and Photos 2 and 4 show the pad.

Photo 1. The access road.

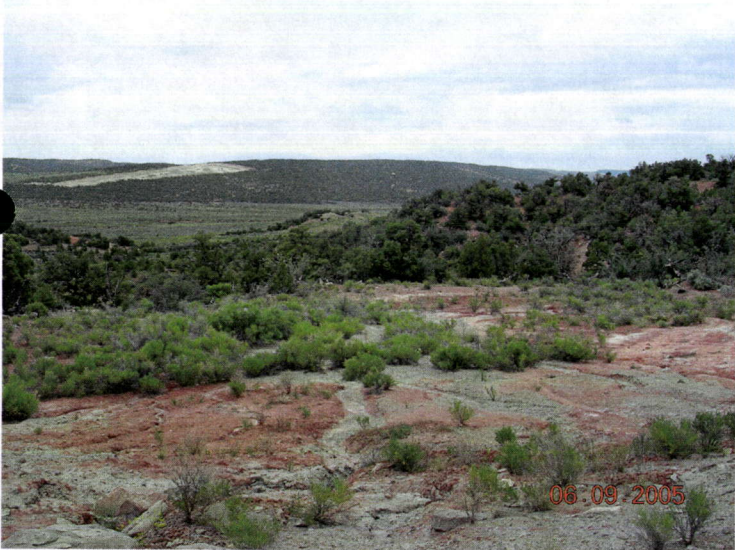
Erosion is not a problem on most of the site, but there are some slopes toward the south part of the area where there has been some erosion (Photo 3). These slopes appear to have a lot of clay, there is not much vegetation, and there is a small drainage that comes down from undisturbed areas above the mine. Much of the sediment coming off the slope settles out on the pad (Photo 2), but some goes farther down the hill.

Photo 2. The mine pad. Water from undisturbed areas above the mine has flowed across this area and deposited some sediment.

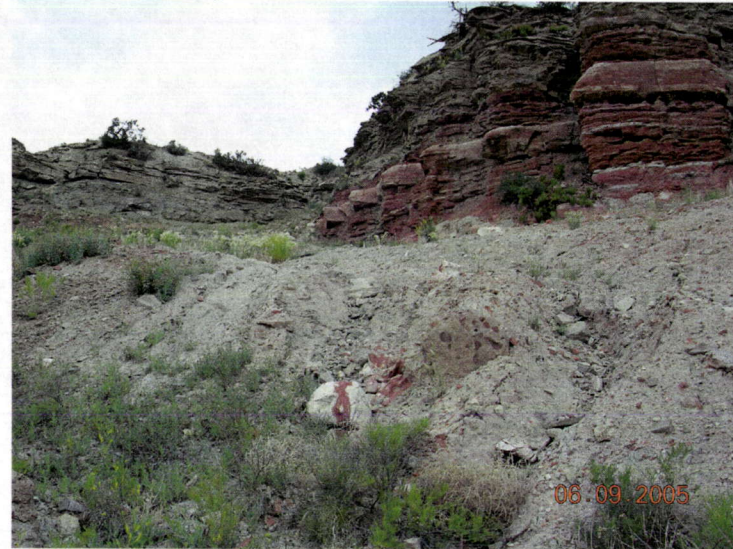
Photo 3. There is some erosion where runoff from undisturbed areas crosses part of the reclaimed highwall.

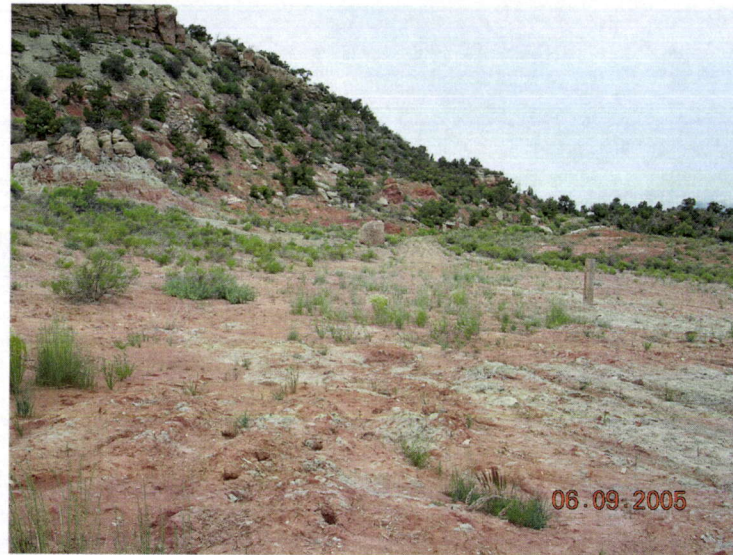
Photo 4. Another view of the pad.

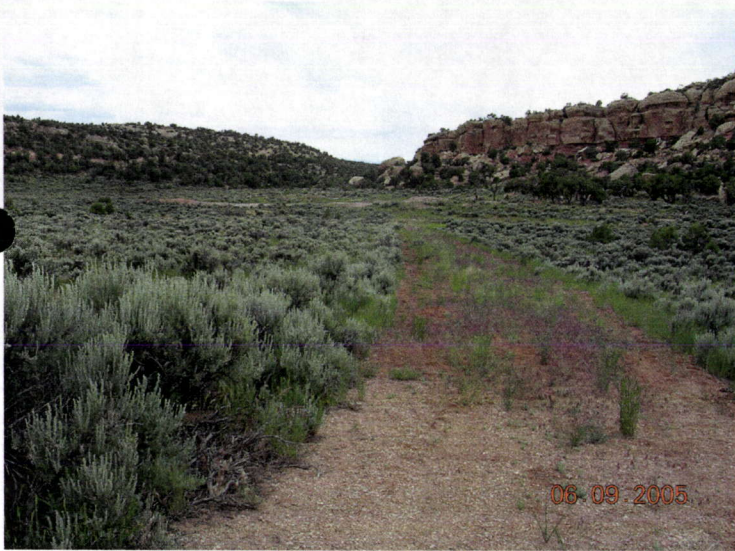
On top of the plateau, there are three road segments that were reclaimed. While there are some weeds in these areas, the vegetation is generally looking good (Photos 5 and 6).

Photo 5. Road leading to a vent hole on top of the plateau.

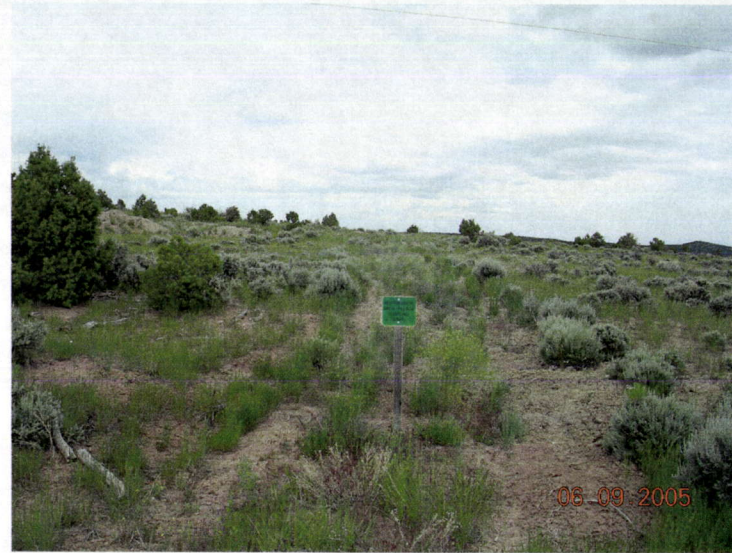
Photo 6. Another road on top of the plateau. Vegetation along this road is almost identical to adjacent areas.
